RESULTS OF DEBRIS AVOIDANCE MANEUVERS AND FORWARD FOIL BROACHES
IN CALM WATER PERFORMED BY THE HYDROFOIL SHIP PCH 1

DAVID W. TAYLOR NAVAL SHIP RESEARCH AND DEVELOPMENT CENTER

STRUCTURES DEPARTMENT
RESEARCH AND DEVELOPMENT REPORT

June 1985

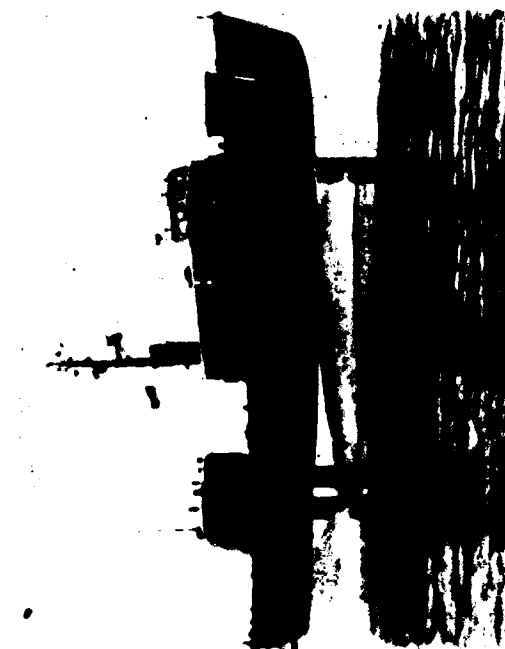
INITIAL STARBOARD TURN

PORT TURN

STRAIGHT AND LEVEL FLIGHT

TRANSITION TO EQUAL AND OPPOSITE PORT TURN

Figure 3 - Overall View of PCH 1 MOD 1 Performing a Debris Avoidance Maneuver

Movies of the debris avoidance maneuver were taken from a stationary chase boat during conditions a) through h) of Table 1 as the ship flew by (see Figure 3). Hull-mounted video cameras were operated during all test maneuvers to record the hydrodynamic flow over the forward foil, port and starboard semispans, and over the aft foil port tip. For the starboard semispan and the aft foil tip, data recording time had to be shared on a single video tape.

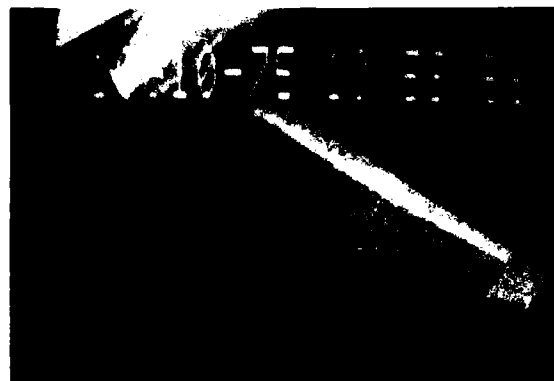
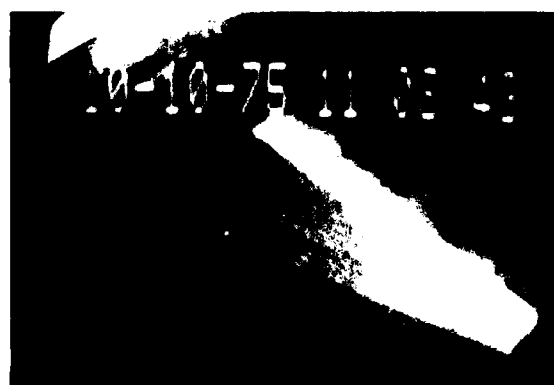
10:55:40.0
STRUT ANGLE = 2.9°
FLAP ANGLE = 2.8°

10:59:55.96
STRUT ANGLE = 5.4°
FLAP ANGLE = 5.6°

11:03:52.0
STRUT ANGLE = 7.0°
FLAP ANGLE = 9.7°

11:08:43.60
STRUT ANGLE = 9.7°
FLAP ANGLE = 13.5°

Figure 23 - Forward Foil Flow--Steady Starboard Turns at 36 Knots for Helm Angles of 45° , 90° , 135° , and 180°

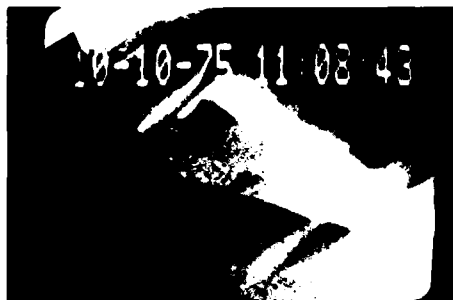
Figure 25 - Forward Foil Flow--Debris Avoidance Maneuver, Initial 180°
Starboard Helm 36 Knots

11:08:43.84
STRUT ANGLE = 9.3°
FLAP ANGLE = 13.8°

PORT SEMI SPAN
ROLL ANGLE = 17.5°

11:08:44.04
STRUT ANGLE = 7.1°
FLAP ANGLE = 13.8°

PORT SEMI SPAN
ROLL ANGLE = 16.4°

11:08:44.16
STRUT ANGLE = 5.6°
FLAP ANGLE = 13.2°

PORT SEMI SPAN
ROLL ANGLE = 15.1°

11:08:44.28
STRUT ANGLE = 3.1°
FLAP ANGLE = 12.6°

PORT SEMI SPAN
ROLL ANGLE = 13.7°

11:08:44.80
STRUT ANGLE = -5.0°
FLAP ANGLE = 9.7°

PORT SEMI SPAN
ROLL ANGLE = 5.4°

11:08:44.96
STRUT ANGLE = -7.2°
FLAP ANGLE = 9.3°

PORT SEMI SPAN
ROLL ANGLE = 1.2°

11:00:45.12 PORT SEMI SPAN
STRUT ANGLE = -12.4° ROLL ANGLE = 2.0°
FLAP ANGLE = 8.2°

11:00:45.30 PORT SEMI SPAN
STRUT ANGLE = -9.7° ROLL ANGLE = -5.6°
FLAP ANGLE = 7.9°

11:00:45.54 PORT SEMI SPAN
STRUT ANGLE = -10.2° ROLL ANGLE = -7.0°
FLAP ANGLE = 7.8°

Flow patterns for submerged forward foil and strut areas are shown in Figures 25 and 26 for full helm displacement at 36 and 45 knots during the maneuver. At the time of transition from full starboard to full port helm, cavitation and cavity shedding could be seen on the port side of the forward strut. In Figure 5, the upper strut bending strain gage bridge (P4803) is shown to have responded to the buffet loads during the time interval in which cavity shedding is evident in Figure 26. Steady sheet cavitation is also evident at the outboard leading edge of the port semispan during the time interval in which roll velocity is maximum. This condition is presumably due to the increase in local angle of attack induced by roll velocity.

The debris avoidance maneuver of Figure 4 resulted in a momentary hydrodynamic loading of the forward strut that approached maximum attainable side force for the submergence involved, as evidenced by the cavity shedding in Figures 25 and 26. (See also Figures 7 and 8 of Rothblum et al.* for correlation of strut cavity shedding with maximum side force coefficient.) The sequence of events that results in this condition can be explained upon examination of the automatic control system schematic presented in Figure A-1 of Appendix A. The rudder servo is driven by the output of the roll angle gyro ($K_{\phi R}$) and the yaw rate gyro (K_{RR}) with gains as shown in Table A-1. Referring to the initial full-helm steady turn data of Figure 4, the roll angle of 18° calls for a strut rotation of $1.34 \times 18^\circ = 26.1^\circ$ nose right in a right hand turn. The yaw rate of $8.5^\circ/\text{s}$ calls for a strut rotation of $-2.0 \times 8.5^\circ = -17^\circ$ nose left. The net nose right strut deflection is 9.1° , which is close to the measured initial strut deflection angle of 8.6° reported in Figure 26 at 11:27:09.6.

Figure 37 shows the hydrodynamic loading on the forward strut at the time of maximum side load as given in Figure 18 superimposed on strut model test data taken from Rothblum et al.* In Figure 37 the model strut loadings correspond to cases where the plots of side force coefficient (C_y) versus side slip angle (β) have a clearly defined ventilation- or cavitation-limited maximum. The peak loading shown corresponds to $C_{y_{\max}} \times \text{dynamic pressure } (1/2 \rho V^2)$. Two of the model test struts had hydrodynamic sections similar to that of HIGH POINT. As Figure 37 shows, the full scale loadings agree generally with the model data at corresponding speeds, and hence near-surface cavitation numbers. Since the full scale strut did not ventilate, the maximum attainable loading was presumably somewhat higher than the model test value. The aspect ratio shown corresponds to the ratio of strut submergence to strut chord, which on HIGH POINT is approximately one. Although Rothblum et al.* showed that aspect ratio substantially affected initial slope of the curves of C_y versus β , it affected maximum attainable hydrodynamic loading substantially less. They also showed a significant buffet load on the model struts near maximum loading due to cavitation cavity shedding just prior to strut ventilation. This buffet load is also evident in the HIGH POINT upper forward strut bending bridge (P4803) during the brief time interval that cavity shedding occurred (Figures 25 and 26).
